# Access Compliance Report Public Rights-of-Way (Curb Ramps)

Main Street: SALIENTE\_RD Cross Street: ESENCIA\_DR Location: NW

ADA ID: RPAT211104105512 Ramp Type: Type 1 - Perpendicular Diagonal Initial Pass/Fail: Fail Overall Compliance: No Severity Score: 2

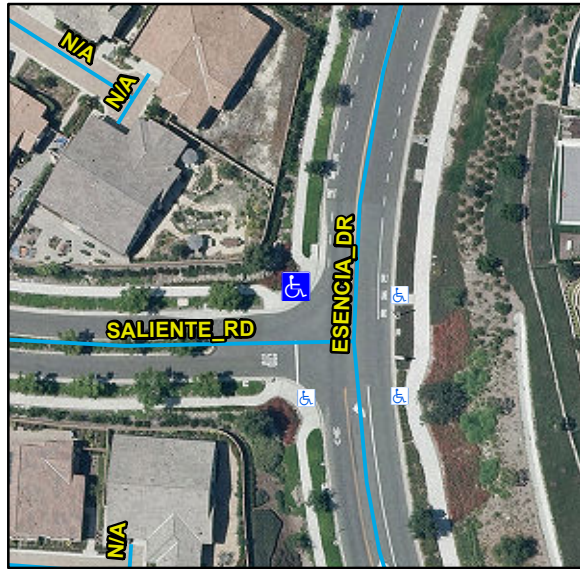
| Compliance | Description | Data | Compliance | Description | Data |
|---|---|---|---|---|---|
| No | Ramp Cross Slope (%) | 3.8 | N/A | Flare Traversable LT | N/A |

Remove & Replace Curb Ramp With Two New Directional Ramps or Equivalent.
