# Access Compliance Report Public Rights-of-Way (Curb Ramps)

Main Street: LOCH\_LOMOND\_RD Cross Street: CHESNEY\_DR Location: SE

ADA ID: RPAT211201084227 Ramp Type: Type 1 - Perpendicular Diagonal Initial Pass/Fail: Fail Overall Compliance: No Severity Score: 15

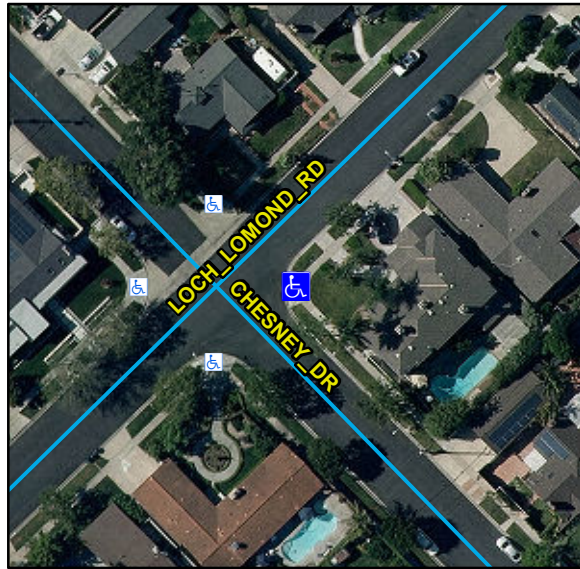
| Compliance | Description | Data | Compliance | Description | Data |
|---|---|---|---|---|---|
| No | Ramp Run Slope (%) | 8.4 | N/A | Flare Slope LT (%) | N/A |

Remove & Replace Curb Ramp With Two New Directional Ramps or Equivalent.

R204.3, R304.2.2, STD 1115
