# Access Compliance Report Public Rights-of-Way (Curb Ramps)

Main Street: CHESNEY\_DR Cross Street: LOCH\_LOMOND\_RD Location: SW

ADA ID: RPAT211201085411 Ramp Type: Type 1 - Perpendicular Diagonal Initial Pass/Fail: Fail Overall Compliance: No Severity Score: 15

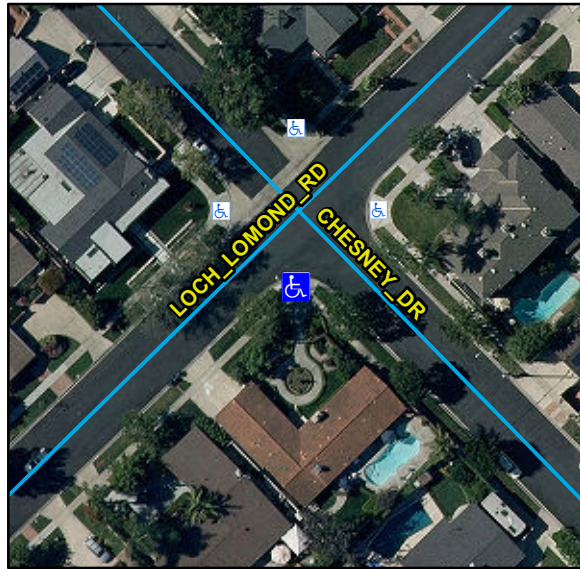
| Compliance | Description | Data | Compliance | Description | Data |
|---|---|---|---|---|---|
| No | Ramp Run Slope (%) | 9.2 | N/A | Flare Slope LT (%) | N/A |

Remove & Replace Curb Ramp With Two New Directional Ramps or Equivalent.
