# Access Compliance Report Public Rights-of-Way (Curb Ramps)

| Parcel ID Number | 086-552-06 | Street 1 Name | CHESNEY_DR |

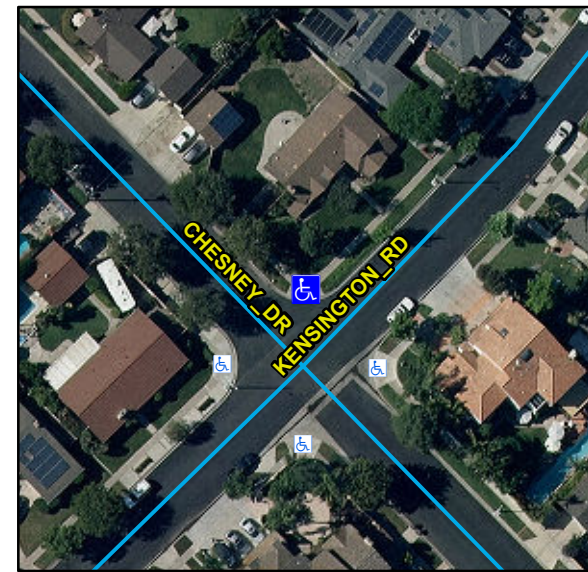
| Compliance | Description | Data | Compliance | Description | Data |
|---|---|---|---|---|---|
| No | Ramp Run Slope (%) | 8.8 | N/A | Flare Slope LT (%) | N/A |
| N/A | Gutter Ponding | N/A | No | Curb Slope | 5.4 |

**Remove & Replace Curb Ramp With Two New Directional Ramps or Equivalent.**

**R304.2.2, R204.3, STD 1115**
