# Access Compliance Report Public Rights-of-Way (Curb Ramps)

| Main Street: SHAKESPEARE_DR | | Cross Street: LOCH_LOMOND_RD | | Location: | N |
| ADA ID: RPAT211201113620 | Ramp Type:Type 1 - Perpendicular Diagonal Initial Pass/Fail: Fail | | Overall Compliance: No | Severity Score: | 15 |

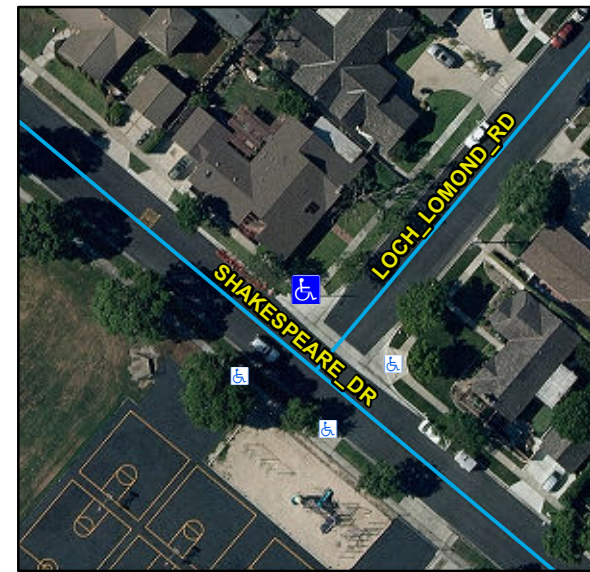
| Compliance | Description | Data | Compliance | Description | Data |
|---|---|---|---|---|---|
| No | Ramp Run Slope (%) | 10 | N/A | Flare Slope LT (%) | N/A |

**Remove & Replace Curb Ramp With Two New Directional Ramps or Equivalent.**
