# Access Compliance Report Public Rights-of-Way (Curb Ramps)

Main Street: NORGROVE\_LN Cross Street: COLERIDGE\_DR Location: W

ADA ID: RPAT211202133607 Ramp Type: Type 1 - Perpendicular Diagonal Initial Pass/Fail: Fail Overall Compliance: No Severity Score: 4

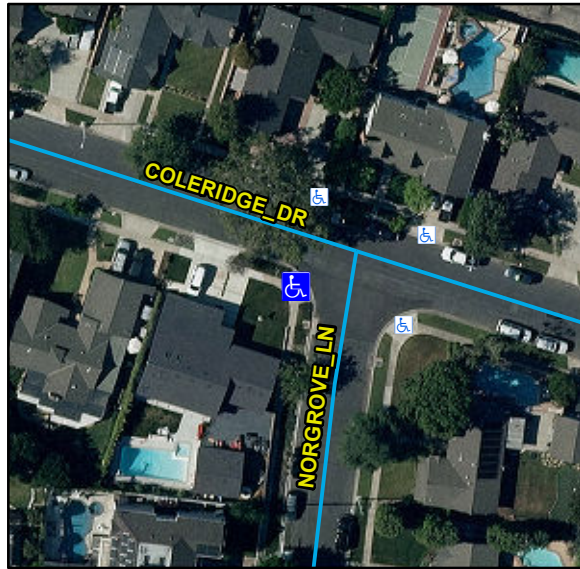
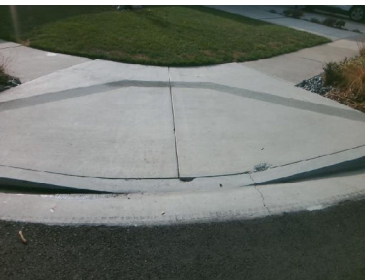
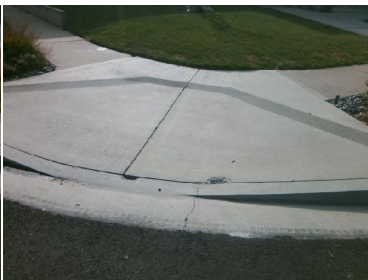
R304.2.2, R204.3, R304.5.1, STD 1115

| Compliance | Description | Data | Compliance | Description | Data |
|---|---|---|---|---|---|
| No | Ramp Width (in) | 47 | | | N/A |

Remove & Replace Curb Ramp With Two New Directional Ramps or Equivalent.
