# Access Compliance Report Public Rights-of-Way (Curb Ramps)

Main Street: COLERIDGE\_DR Cross Street: NORGROVE\_LN Location: S

ADA ID: RPAT211202133836 Ramp Type: Type 1 - Perpendicular Diagonal Initial Pass/Fail: Fail Overall Compliance: No Severity Score: 2

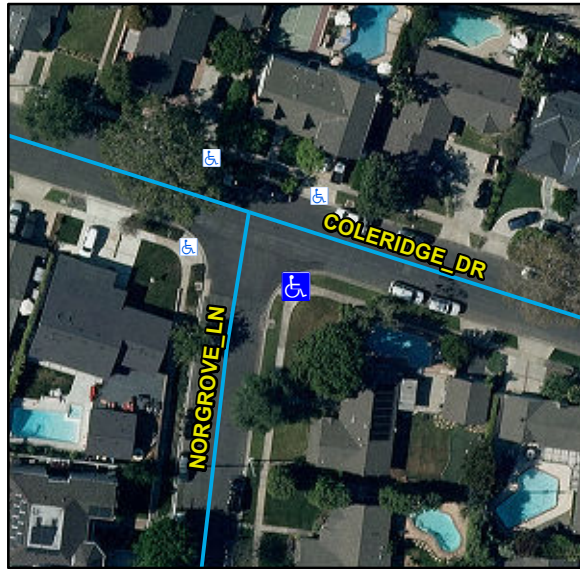
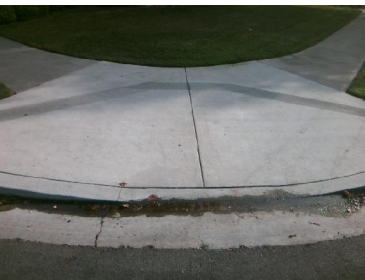
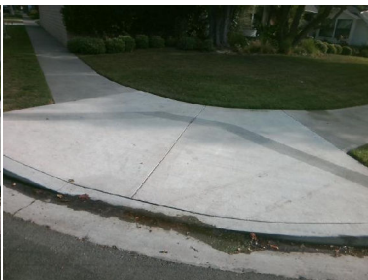
| Compliance | Description | Data | Compliance | Description | Data |
|---|---|---|---|---|---|
| No | Ramp Cross Slope (%) | 3.5 | N/A | Flare Traversable LT | N/A |

Remove & Replace Curb Ramp With Two New Directional Ramps or Equivalent.
