# Access Compliance Report Public Rights-of-Way (Curb Ramps)

| Main Street: CIMA_DR | | Cross Street: N/A | | Location: | N |
| ADA ID: RPAT220125111714 | Ramp Type:Type 1 - Perpendicular | Initial Pass/Fail: Fail | Overall Compliance: No | Severity Score: | 15 |

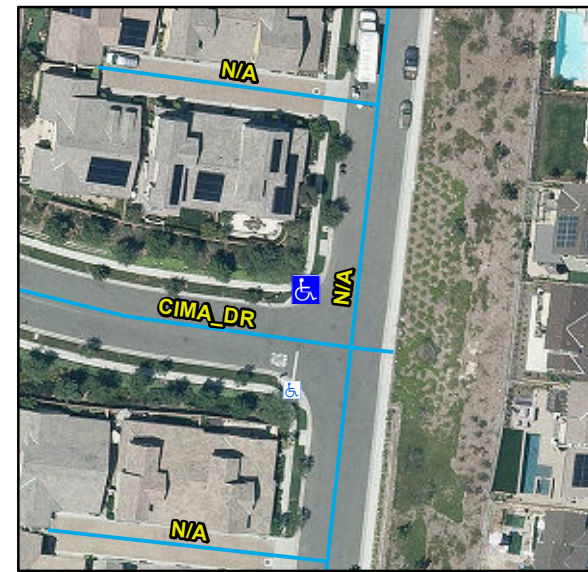
| Compliance | Description | Data | Compliance | Description | Data |
|---|---|---|---|---|---|
| No | Ramp Run Slope (%) | 9.4 | N/A | Flare Slope LT (%) | N/A |

Remove & Replace Entire Ramp.

R304.2.2, STD 1115
