# Access Compliance Report Public Rights-of-Way (Curb Ramps)

| Main Street: FRONTERA_ST | | Cross Street: N_GLASSELL_ST | | Location: | NE |
| ADA ID: RPAT220127092606 | Ramp Type:Type 1 - Perpendicular | Initial Pass/Fail: Fail | Overall Compliance: No | Severity Score: | 20 |

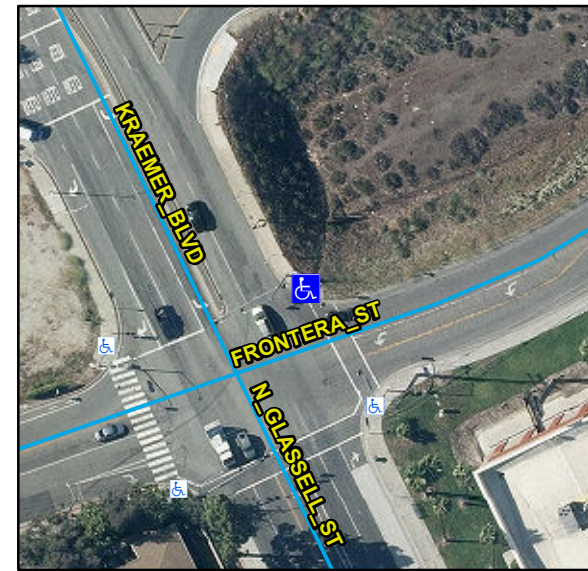
**R304.2.2, R204.3, R304.5.1, R304.5.3, R302.7, STD 1115**

| Compliance | Description | Data | Compliance | Description | Data |
|---|---|---|---|---|---|
| No | Ramp Width (in) | 45 | | | N/A |
| No | Ramp Cross Slope (%) | 2.5 | N/A | Flare Traversable LT | N/A |
| No | Overall Surface Condition: | Poor | No | Perp Joint Present | No |

**Remove & Replace Entire Ramp. Restripe Crosswalk.**
