# Access Compliance Report Public Rights-of-Way (Curb Ramps)

Main Street: FRONTERA\_ST Cross Street: N\_GLASSELL\_ST Location: NW

ADA ID: RPAT220127093815 Ramp Type: Type 1 - Perpendicular Initial Pass/Fail: Fail Overall Compliance: No Severity Score: 19

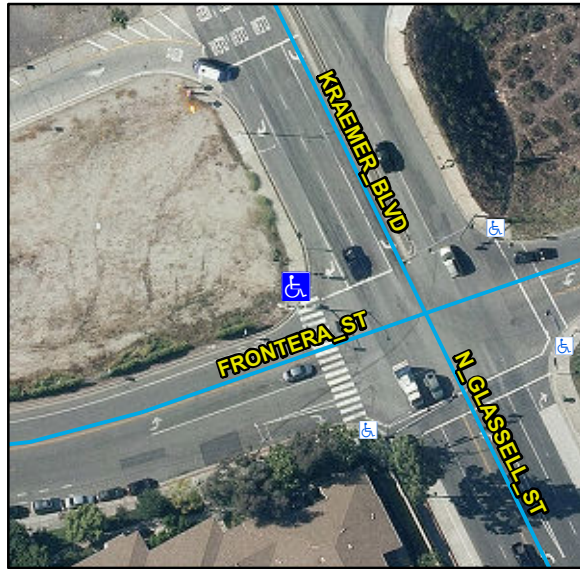
R304.2.2, R304.5.1, R302.7, STD 1115

Remove & Replace Entire Ramp.

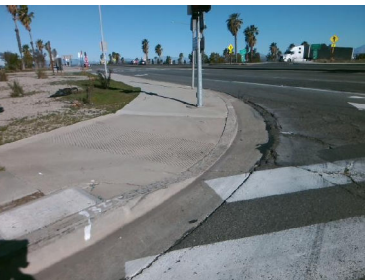
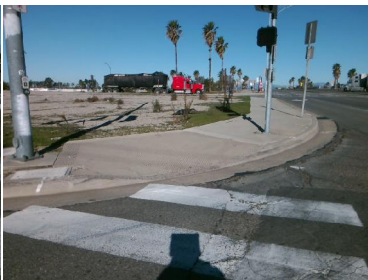
| Compliance | Description | Data | Compliance | Description | Data |
|---|---|---|---|---|---|
| No | Ramp Width (in) | 47 | | | N/A |
| N/A | Gutter Ponding | N/A | No | Curb Slope | 7.3 |
| No | Overall Surface Condition: | Poor | Yes | Perp Joint Present | Yes |
