# Access Compliance Report Public Rights-of-Way (Curb Ramps)

Main Street: LINCOLN\_AVE Cross Street: ORANGE\_OLIVE\_RD Location: SE

ADA ID: RPAT220127102614 Ramp Type: Type 1 - Perpendicular Diagonal Initial Pass/Fail: Fail Overall Compliance: No Severity Score: 45

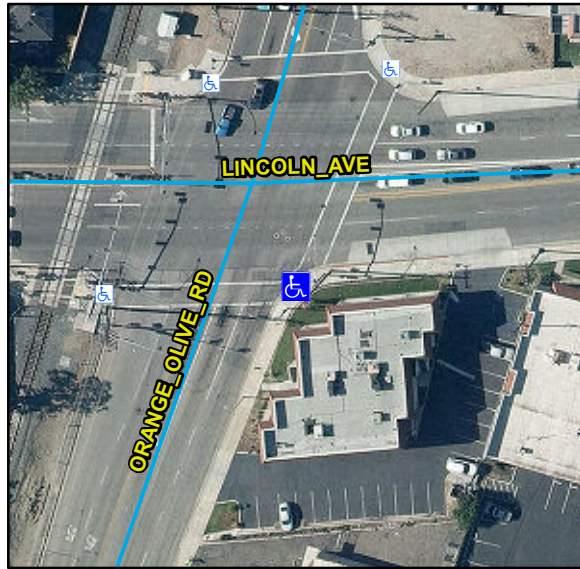
| Compliance | Description | Data | Compliance | Description | Data |
|---|---|---|---|---|---|
| No | Ramp Cross Slope (%) | 9.3 | N/A | Flare Traversable LT | N/A |
| No | Overall Surface Condition: | Poor | Yes | Perp Joint Present | Yes |

Remove & Replace Curb Ramp With Two New Directional Ramps or Equivalent.
