# Access Compliance Report Public Rights-of-Way (Curb Ramps)

| Main Street: SANTO_TOMAS_ST | | Cross Street: SANTA_ANA_AVE | | Location: | N |
| ADA ID: RPAT220128165320 | Ramp Type:Type 1 - Perpendicular | Initial Pass/Fail: Fail | Overall Compliance: No | Severity Score: | 16 |

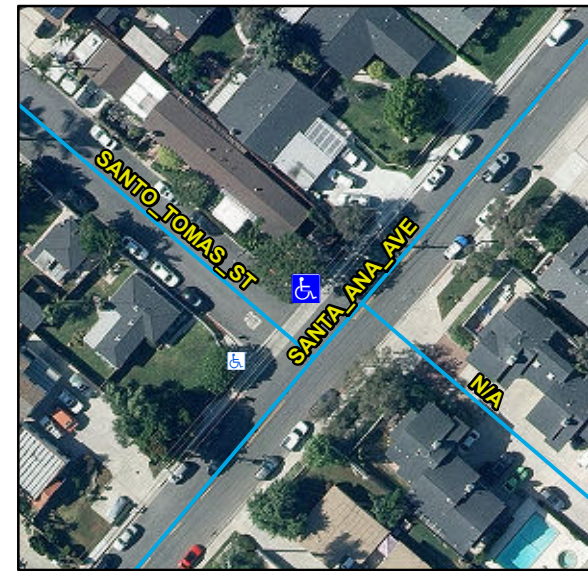
R304.2.2, R204.3, R304.5.3, R302.7, STD 1115

| Compliance | Description | Data | Compliance | Description | Data |
|---|---|---|---|---|---|
| No | Ramp Cross Slope (%) | 2.3 | N/A | Flare Traversable LT | N/A |
| No | Overall Surface Condition: | Poor | No | Perp Joint Present | No |

Remove & Replace Entire Ramp.
