# Access Compliance Report Public Rights-of-Way (Curb Ramps)

Main Street: BROOKHURST\_ST Cross Street: CERRITOS\_AVE Location: SE

ADA ID: RPAT220202142749 Ramp Type: Type 1 - Perpendicular Diagonal Initial Pass/Fail: Pass Overall Compliance: No Severity Score: 2

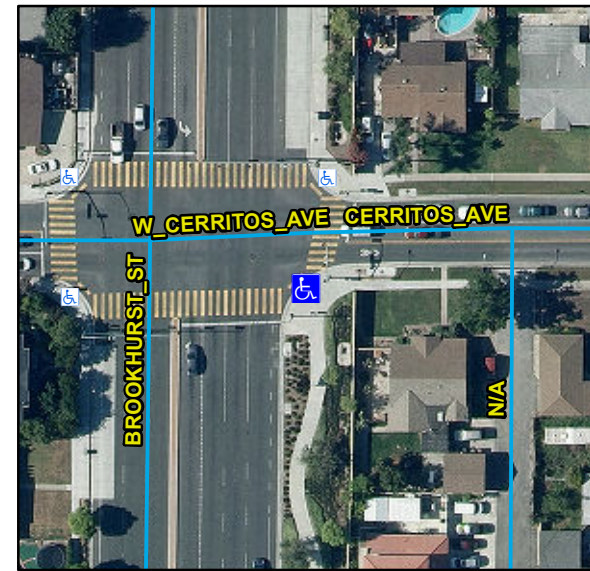
| Compliance | Description | Data | Compliance | Description | Data |
|---|---|---|---|---|---|
| Yes | Gutter Ponding | No | No | Curb Slope | 7.1 |

Possible Solutions:  
**Remove & Replace Curb Slope.**

OC Std/PROW:  
**R304.2.2, STD 1115**
