# Access Compliance Report Public Rights-of-Way (Curb Ramps)

Main Street: GUINIDA\_LN Cross Street: FLORIN\_LN Location: NW

ADA ID: RPAT220203102646 Ramp Type: Type 4 - Parallel Initial Pass/Fail: Fail Overall Compliance: No Severity Score: 15

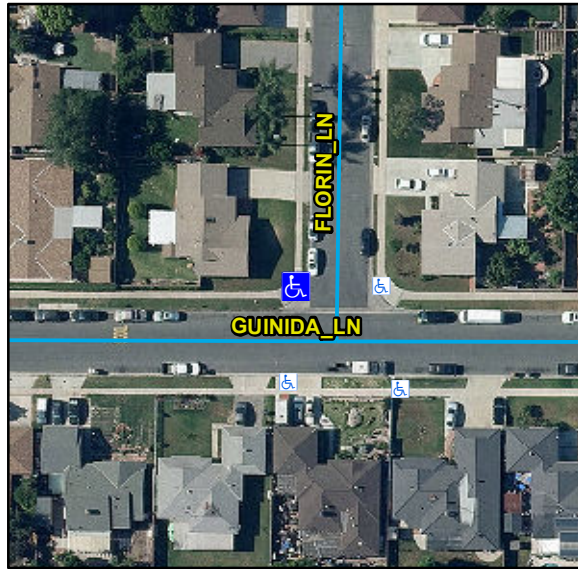
| Compliance | Description | Data | Compliance | Description | Data |
|---|---|---|---|---|---|
| No | Ramp Cross Slope LT (%) | 4.7 | No | Ramp Cross Slope RT (%) | 5.8 |

**Remove & Replace Curb Ramp With Two New Directional Ramps or Equivalent.**

**R304.5.3, STD 1115**
