# Access Compliance Report Public Rights-of-Way (Curb Ramps)

| Main Street: HEDLUND_DR | | Cross Street: HARLE_AVE | | Location: | SE |
| ADA ID: RPAT220203142337 | Ramp Type: Type 4 - Parallel | Initial Pass/Fail: Fail | Overall Compliance: No | Severity Score: | 4 |

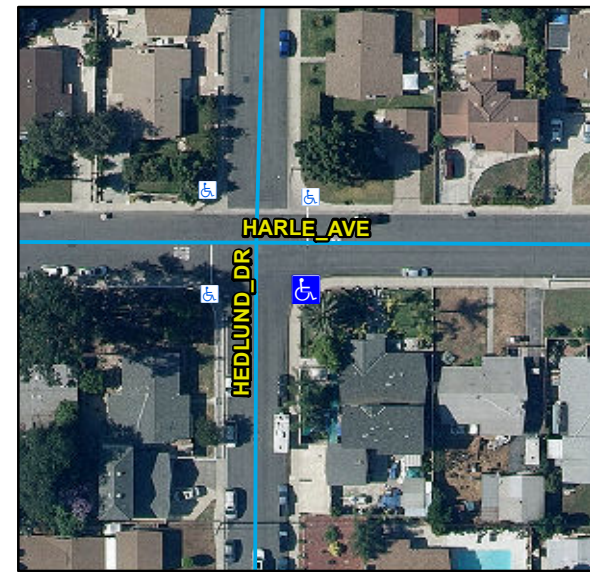
| Compliance | Description | Data | Compliance | Description | Data |
|---|---|---|---|---|---|
| No | Ramp Width LT (in) | 47 | No | Ramp Width RT (in) | 47 |

**Remove & Replace Curb Ramp With Two New Directional Ramps or Equivalent.**

**R304.5.1, STD 1115**
