# Access Compliance Report Public Rights-of-Way (Curb Ramps)

Main Street: PERDIDO\_ST Cross Street: LULLABY\_LN Location: NE

ADA ID: RPAT220203160108 Ramp Type: Type 4 - Parallel Initial Pass/Fail: Fail Overall Compliance: No Severity Score: 4

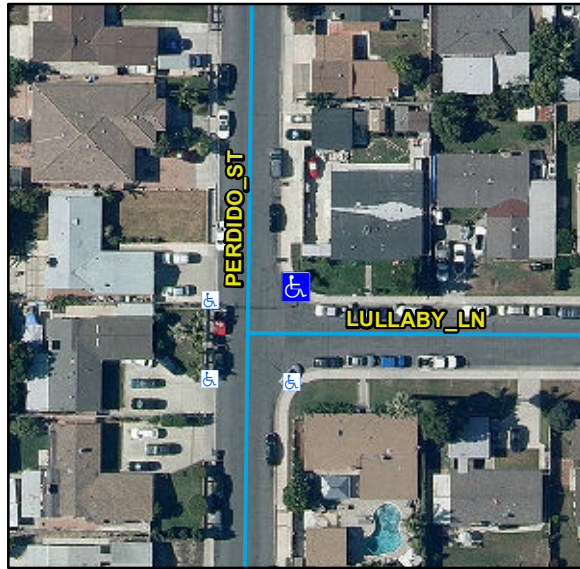
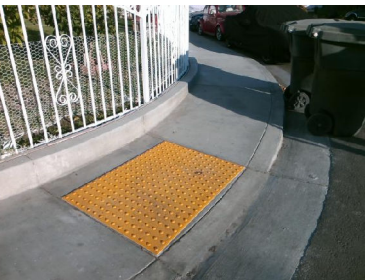
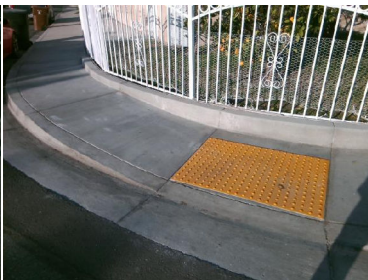
| Compliance | Description | Data | Compliance | Description | Data |
|---|---|---|---|---|---|
| No | Ramp Width LT (in) | 47 | No | Ramp Width RT (in) | 47 |

**Remove & Replace Curb Ramp With Two New Directional Ramps or Equivalent.**

**R304.5.1, STD 1115**
