# Access Compliance Report Public Rights-of-Way (Curb Ramps)

Main Street: WOODSONG Cross Street: GREENVALE Location: E

ADA ID: RPAT220208115636 Ramp Type: Type 1 - Perpendicular Diagonal Initial Pass/Fail: Fail Overall Compliance: No Severity Score: 20

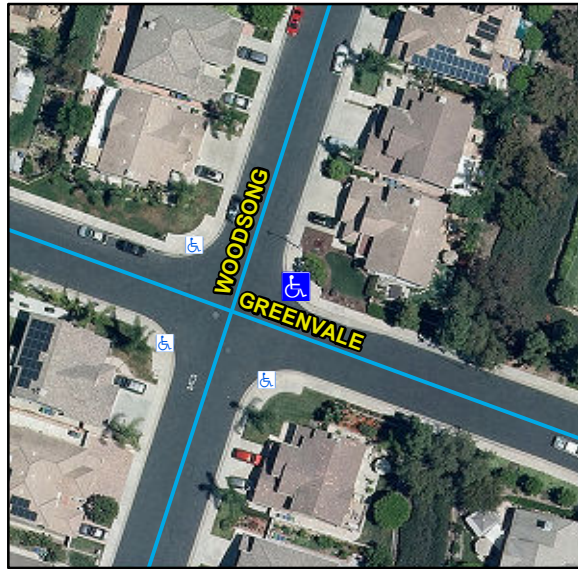
R304.2.2, R204.3, R304.5.1, R304.5.3, STD 1115

| Compliance | Description | Data | Compliance | Description | Data |
|---|---|---|---|---|---|
| No | Ramp Width (in) | 45 | | | N/A |
| No | Ramp Run Slope (%) | 10.94 | N/A | Flare Slope LT (%) | N/A |
| No | Ramp Cross Slope (%) | 4.5 | N/A | Flare Traversable LT | N/A |

Remove & Replace Curb Ramp With Two New Directional Ramps or Equivalent.
