# Access Compliance Report Public Rights-of-Way (Curb Ramps)

Main Street: GREENVALE Cross Street: WOODSONG Location: S

ADA ID: RPAT220208120423 Ramp Type: Type 1 - Perpendicular Diagonal Initial Pass/Fail: Fail Overall Compliance: No Severity Score: 34

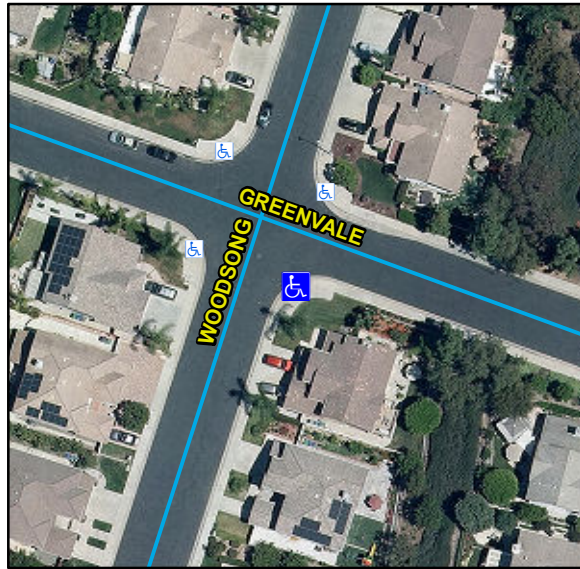
| Compliance | Description | Data | Compliance | Description | Data |
|---|---|---|---|---|---|
| No | Ramp Width (in) | 44 | | | N/A |
| No | Ramp Run Slope (%) | 9.37 | N/A | Flare Slope LT (%) | N/A |
| No | Ramp Cross Slope (%) | 5.7 | N/A | Flare Traversable LT | N/A |

Remove & Replace Curb Ramp With Two New Directional Ramps or Equivalent.
