# Access Compliance Report Public Rights-of-Way (Curb Ramps)

Main Street: WOODSONG Cross Street: GREENVALE Location: W

ADA ID: RPAT220208120702 Ramp Type: Type 1 - Perpendicular Diagonal Initial Pass/Fail: Fail Overall Compliance: No Severity Score: 16

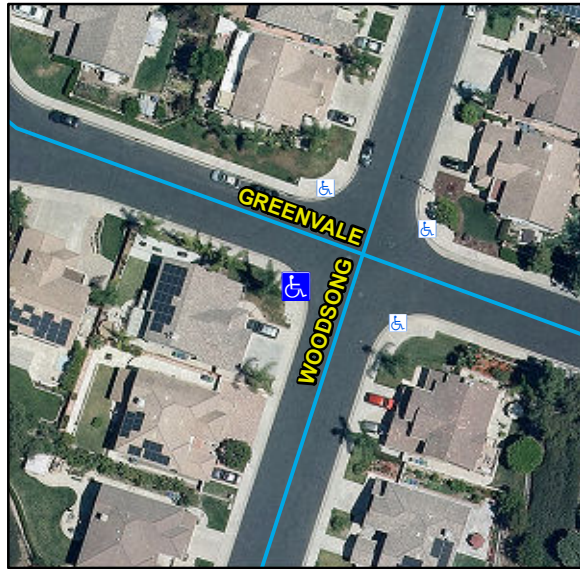
**R304.2.2, R204.3, R304.5.3, STD 1115**

| Compliance | Description | Data | Compliance | Description | Data |
|---|---|---|---|---|---|
| No | Ramp Run Slope (%) | 9.37 | N/A | Flare Slope LT (%) | N/A |
| No | Ramp Cross Slope (%) | 4.1 | N/A | Flare Traversable LT | N/A |

**Remove & Replace Curb Ramp With Two New Directional Ramps or Equivalent.**
