# Access Compliance Report Public Rights-of-Way (Curb Ramps)

Main Street: N/A Cross Street: ANTONIO\_PKWY Location: N

ADA ID: RPAT220208121239 Ramp Type: Type 1 - Perpendicular Diagonal Initial Pass/Fail: Fail Overall Compliance: No Severity Score: 32

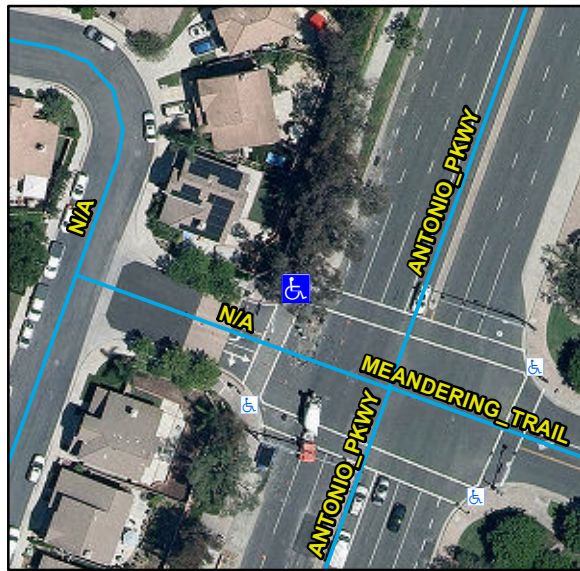
R304.2.2, R204.3, R304.5.3, R302.7, R302.7.2, STD 1115

| Compliance | Description | Data | Compliance | Description | Data |
|---|---|---|---|---|---|
| No | Ramp Run Slope (%) | 9.19 | N/A | Flare Slope LT (%) | N/A |
| No | Ramp Cross Slope (%) | 3.8 | N/A | Flare Traversable LT | N/A |
| No | Gutter Lip Height (in) | 1.5 | | Road Run Slope (%) | 0.69 |
| No | Overall Surface Condition: | Poor | No | Perp Joint Present | No |

Remove & Replace Curb Ramp With Two New Directional Ramps or Equivalent.
