# Access Compliance Report Public Rights-of-Way (Curb Ramps)

Main Street: PALM\_AVE Cross Street: YORBA\_LINDA\_BLVD\_004 Location: NE

ADA ID: RPAT220221101506 Ramp Type: Type 1 - Perpendicular Initial Pass/Fail: Fail Overall Compliance: No Severity Score: 2

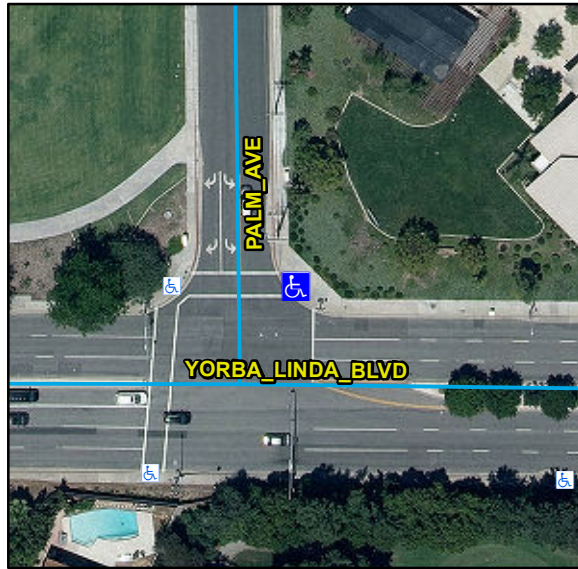
| Compliance | Description | Data | Compliance | Description | Data |
|---|---|---|---|---|---|
| No | Ramp Cross Slope (%) | 2.9 | N/A | Flare Traversable LT | N/A |

Remove & Replace Entire Ramp.

R304.5.3, STD 1115
