# Access Compliance Report Public Rights-of-Way (Curb Ramps)

Main Street: YORBA\_LINDA\_BLV D Cross Street: PALM\_AVE Location: NW

ADA ID: RPAT220221102605 Ramp Type:Type 1 - Perpendicular Diagonal Initial Pass/Fail: Fail Overall Compliance: No Severity Score: 30

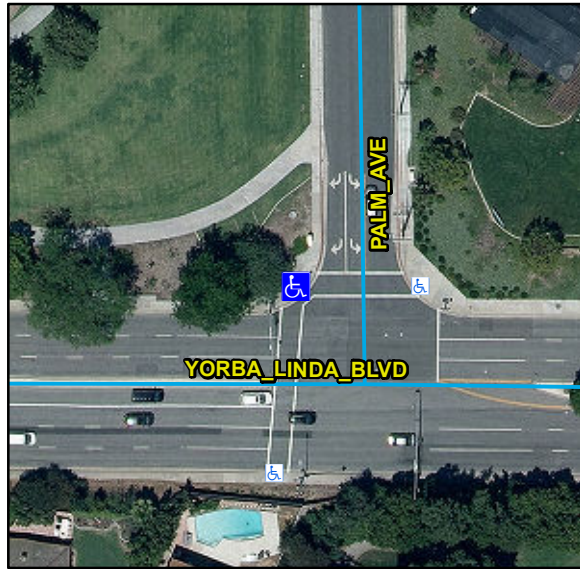
**R304.2.2, R304.5.3, STD 1115**

| Compliance | Description | Data | Compliance | Description | Data |
|---|---|---|---|---|---|
| No | Ramp Cross Slope (%) | 8.2 | N/A | Flare Traversable LT | N/A |

**Remove & Replace Curb Ramp With Two New Directional Ramps or Equivalent.**
