# Access Compliance Report Public Rights-of-Way (Curb Ramps)

| Main Street: N/A | | Cross Street: YORBA_LINDA_BLVD | | Location: | SE |
| ADA ID: RPAT220221113738 | Ramp Type:Type 1 - Perpendicular | Initial Pass/Fail: Fail | Overall Compliance: No | Severity Score: | 15 |

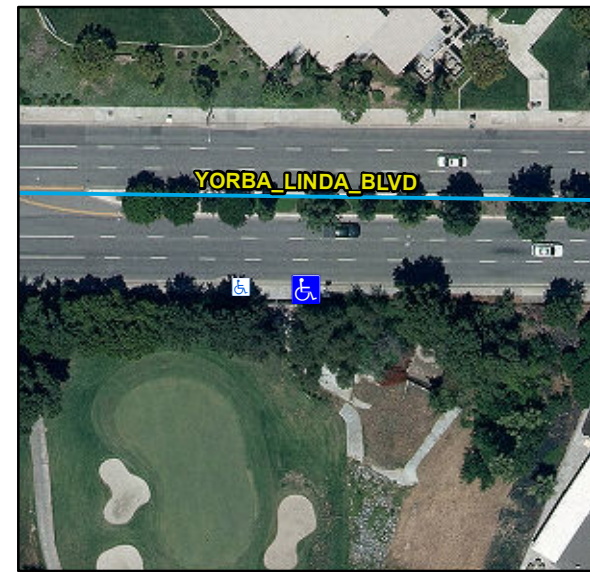
| Compliance | Description | Data | Compliance | Description | Data |
|---|---|---|---|---|---|
| No | Ramp Run Slope (%) | 9.1 | N/A | Flare Slope LT (%) | N/A |
| N/A | Gutter Ponding | N/A | No | Curb Slope | 5.7 |

Possible Solutions:

Remove & Replace Entire Ramp.

R304.2.2, STD 1115
