# Access Compliance Report Public Rights-of-Way (Curb Ramps)

| Main Street: HAZARD_AVE | | Cross Street: NEWLAND_ST | | Location: | SE |
| ADA ID: RPAT220221145723 | Ramp Type: Type 4 - Parallel | Initial Pass/Fail: Fail | Overall Compliance: No | Severity Score: | 30 |

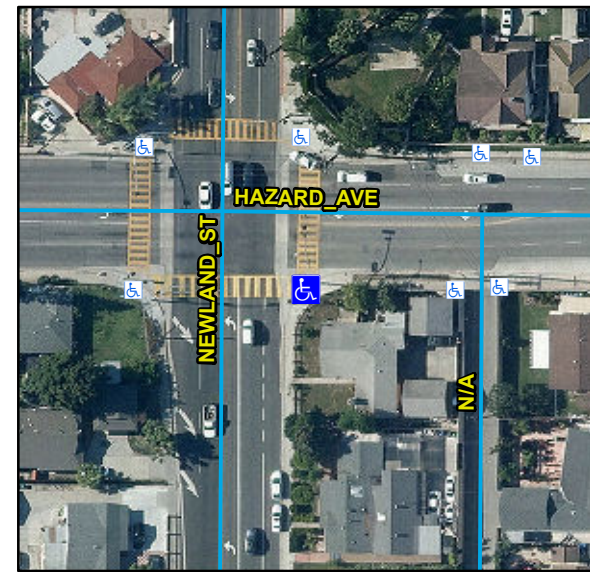
| Compliance | Description | Data | Compliance | Description | Data |
|---|---|---|---|---|---|
| No | Ramp Run Slope LT (%) | 8.5 | Yes | Ramp Run Slope RT (%) | 3.8 |
| No | Overall Surface Condition | Poor | | | |

**Remove & Replace Curb Ramp With Two New Directional Ramps or Equivalent.**

**R304.3.2, R302.7, STD 1115**

Total Cost: \$ 4000
