# Access Compliance Report Public Rights-of-Way (Curb Ramps)

Main Street: LEAFWOOD\_LN Cross Street: YORBA\_ST Location: NE

ADA ID: RPAT220222165056 Ramp Type: Type 1 - Perpendicular Initial Pass/Fail: Fail Overall Compliance: No Severity Score: 2

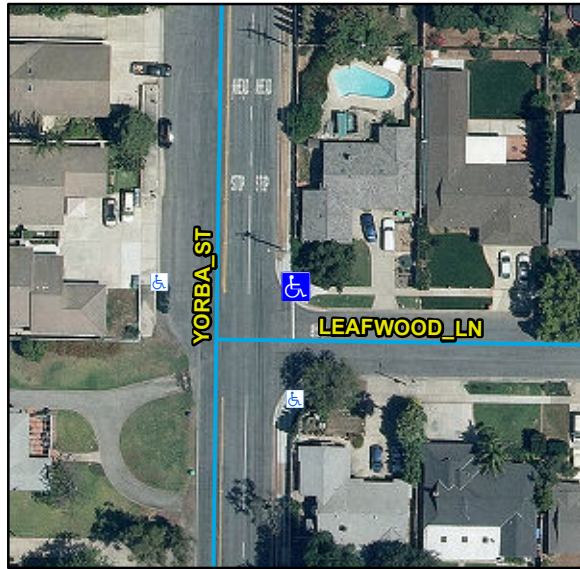
| Compliance | Description | Data | Compliance | Description | Data |
|---|---|---|---|---|---|
| No | Ramp Cross Slope (%) | 2.6 | N/A | Flare Traversable LT | N/A |
| N/A | Gutter Ponding | N/A | No | Curb Slope | 6.3 |

Remove & Replace Entire Ramp.

R304.2.2, R304.5.3, STD 1115
