# Access Compliance Report Public Rights-of-Way (Curb Ramps)

| Main Street: LEAFWOOD_LN | | Cross Street: YORBA_ST | | Location: | SE |
| ADA ID: RPAT220222165338 | Ramp Type:Type 1 - Perpendicular | Initial Pass/Fail: Pass | Overall Compliance: No | Severity Score: | 0 |

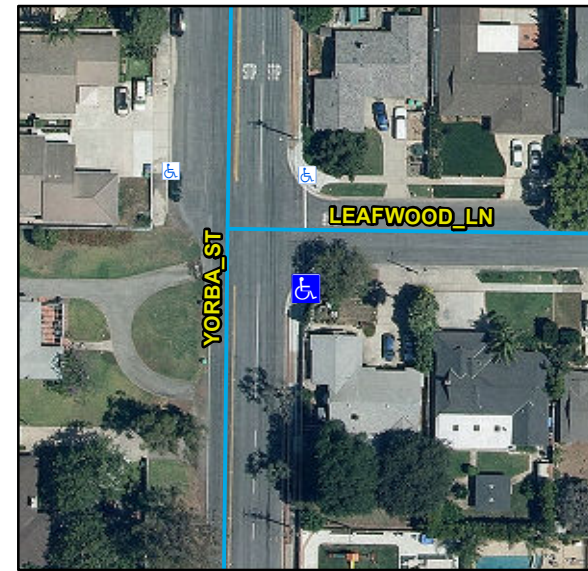
**Remove & Replace Landing. Gutter Ponding Observed.**

| Compliance | Description | Data | Compliance | Description | Data |
|---|---|---|---|---|---|
| No | Landing Cross Slope (%) | 2.6 | Yes | DWS Provided | Yes |
| No | Gutter Ponding | Yes | Yes | Curb Slope | 4.2 |

Possible Solutions:

**R304.2.1, R304.5.3, R302.7, STD 1115**
