# Access Compliance Report Public Rights-of-Way (Curb Ramps)

Main Street: N/A Cross Street: NEWPORT\_BLV Location: SW

ADA ID: RPAT220222175354 Ramp Type:Type 1 - Perpendicular Initial Pass/Fail: Fail Overall Compliance: No Severity Score: 20

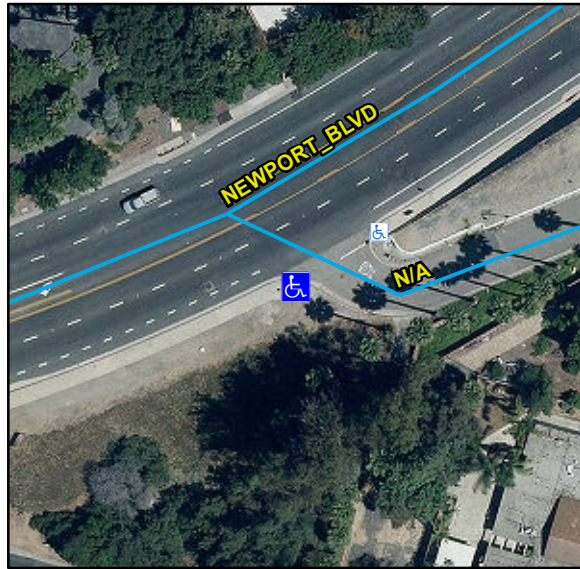
| Compliance | Description | Data | Compliance | Description | Data |
|---|---|---|---|---|---|
| No | Ramp Width (in) | 47 | | | N/A |
| No | Ramp Run Slope (%) | 11.8 | N/A | Flare Slope LT (%) | N/A |
| No | Ramp Cross Slope (%) | 4.3 | N/A | Flare Traversable LT | N/A |
| No | Gutter Lip Height (in) | 1 | | Road Run Slope (%) | N/A |

Remove & Replace Entire Ramp. Grind Gutter Lip.

R304.5.1, R304.2.2, R304.5.3, R302.7.2, STD 1115
