# Access Compliance Report Public Rights-of-Way (Curb Ramps)

Main Street: SHADBURN\_AVE Cross Street: MCCORMACK\_LN Location: SE

ADA ID: RPRK210917162128 Ramp Type: Type 1 - Perpendicular Diagonal Initial Pass/Fail: Fail Overall Compliance: No Severity Score: 2

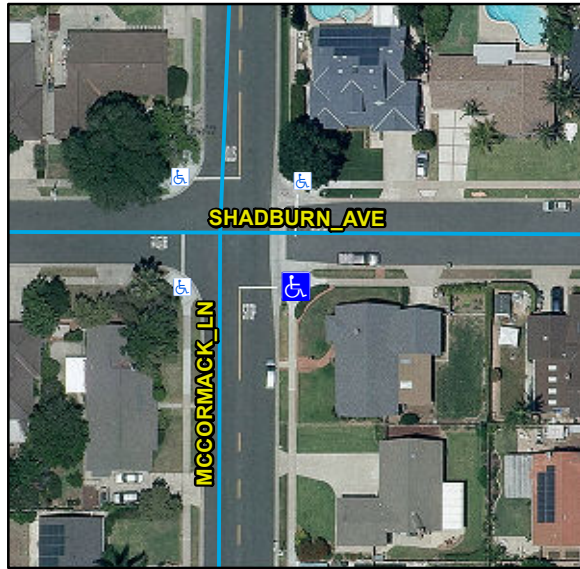
R304.2.2, R304.5.3, STD 1115

| Compliance | Description | Data | Compliance | Description | Data |
|---|---|---|---|---|---|
| No | Ramp Cross Slope (%) | 2.1 | N/A | Flare Traversable LT | N/A |

Remove & Replace Curb Ramp With Two New Directional Ramps or Equivalent.
