# Access Compliance Report Public Rights-of-Way (Curb Ramps)

Main Street: S\_GARZA\_ST Cross Street: CERRITOS\_AVE Location: NE

ADA ID: RPRK210922112956 Ramp Type: Type 1 - Perpendicular Diagonal Initial Pass/Fail: Fail Overall Compliance: No Severity Score: 15

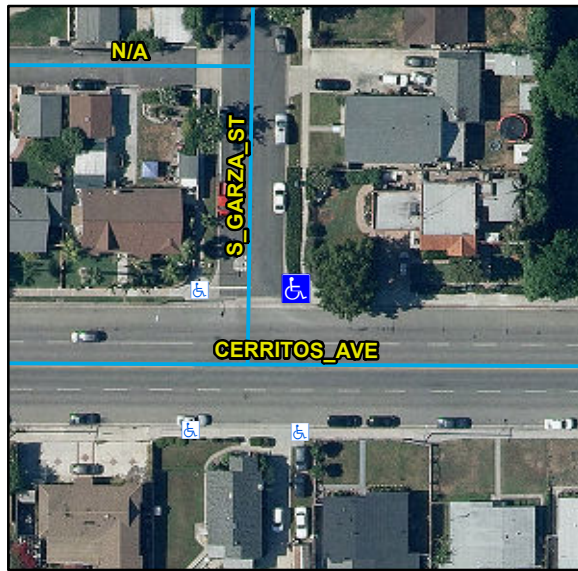
| Compliance | Description | Data | Compliance | Description | Data |
|---|---|---|---|---|---|
| No | Ramp Run Slope (%) | 8.5 | N/A | Flare Slope LT (%) | N/A |
| No | Gutter Lip Height (in) | 0.5 | | Road Run Slope (%) | 5.2 |

Remove & Replace Curb Ramp With Two New Directional Ramps or Equivalent.

R304.2.2, R302.7.2, STD 1115
