# Access Compliance Report Public Rights-of-Way (Curb Ramps)

Main Street: PALAIS\_RD Cross Street: PERDIDO\_ST Location: NW

ADA ID: RPRK210923113733 Ramp Type: Type 1 - Perpendicular Diagonal Initial Pass/Fail: Fail Overall Compliance: No Severity Score: 15

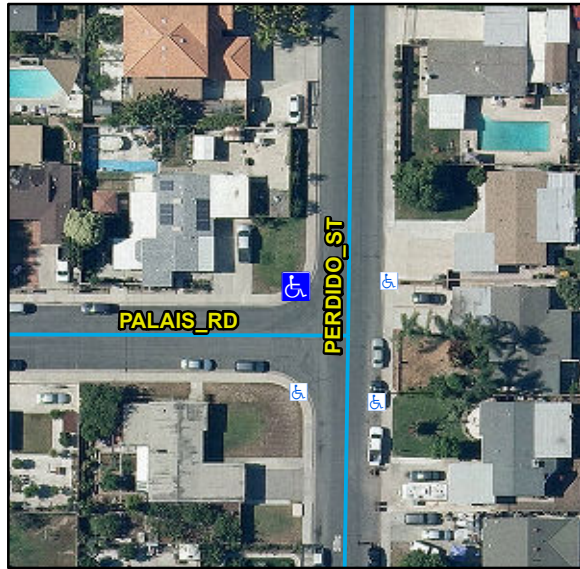
R304.2.2, R204.3, R302.7.2, STD 1115

| Compliance | Description | Data | Compliance | Description | Data |
|---|---|---|---|---|---|
| No | Ramp Run Slope (%) | 10.8 | N/A | Flare Slope LT (%) | N/A |
| No | Gutter Lip Height (in) | 0.5 | | Road Run Slope (%) | 1.3 |

Remove & Replace Curb Ramp With Two New Directional Ramps or Equivalent.
