# Access Compliance Report Public Rights-of-Way (Curb Ramps)

Main Street: GUINIDA\_LN Cross Street: PERDIDO\_ST Location: SE

ADA ID: RPRK210923114802 Ramp Type: Type 1 - Perpendicular Diagonal Initial Pass/Fail: Fail Overall Compliance: No Severity Score: 32

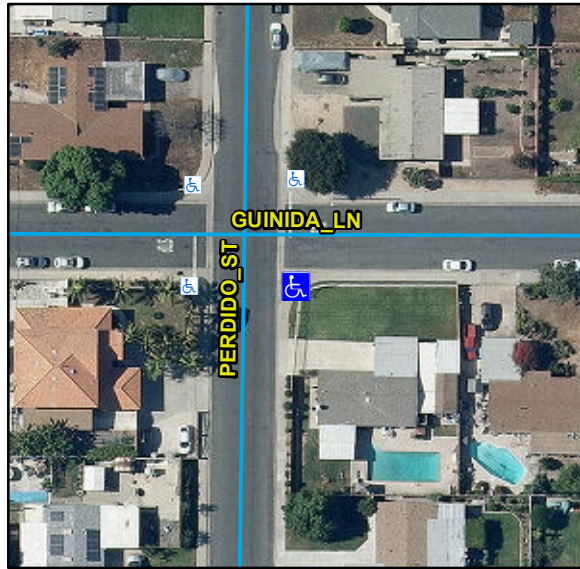
| Compliance | Description | Data | Compliance | Description | Data |
|---|---|---|---|---|---|
| No | Ramp Run Slope (%) | 13.2 | N/A | Flare Slope LT (%) | N/A |
| N/A | Gutter Ponding | N/A | No | Curb Slope | 10.7 |
| No | Gutter Lip Height (in) | 1 | | Road Run Slope (%) | 0.2 |

**Remove & Replace Curb Ramp With Two New Directional Ramps or Equivalent.**
