# Access Compliance Report Public Rights-of-Way (Curb Ramps)

Main Street: PERDIDO\_ST Cross Street: GUINIDA\_LN Location: NE

ADA ID: RPRK210923115018 Ramp Type: Type 1 - Perpendicular Diagonal Initial Pass/Fail: Fail Overall Compliance: No Severity Score: 15

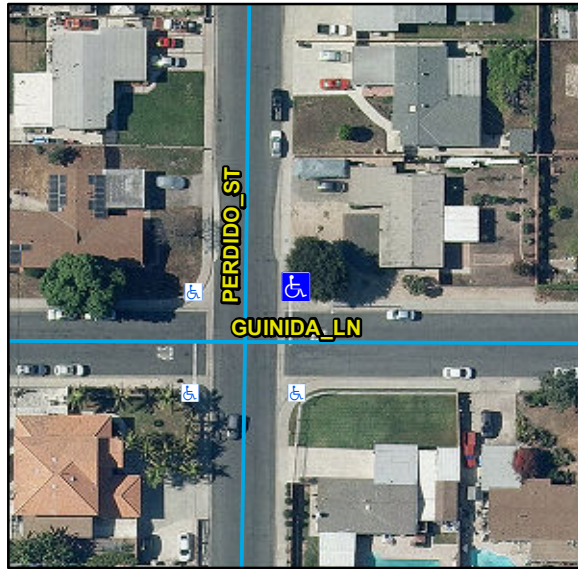
R304.2.2, R204.3, R302.7.2, STD 1115

| Compliance | Description | Data | Compliance | Description | Data |
|---|---|---|---|---|---|
| No | Ramp Run Slope (%) | 11.6 | N/A | Flare Slope LT (%) | N/A |
| No | Gutter Lip Height (in) | 0.5 | | Road Run Slope (%) | 4.3 |

Remove & Replace Curb Ramp With Two New Directional Ramps or Equivalent.
