# Access Compliance Report Public Rights-of-Way (Curb Ramps)

Main Street: GUINIDA\_LN Cross Street: ANTIGUA\_ST Location: SE

ADA ID: RPRK210923151029 Ramp Type: Type 1 - Perpendicular Diagonal Initial Pass/Fail: Fail Overall Compliance: No Severity Score: 32

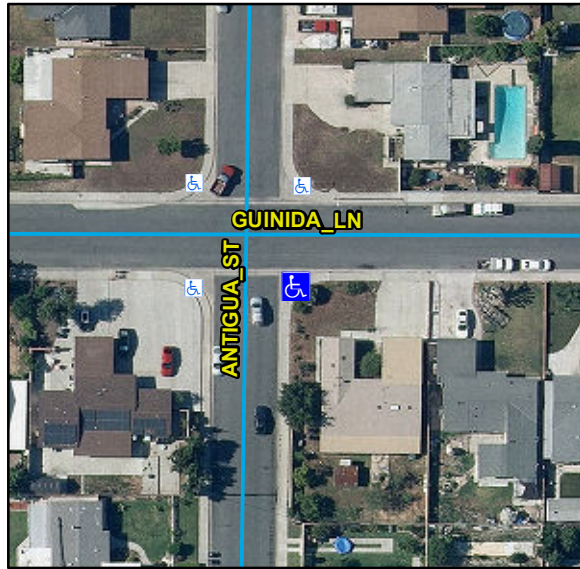
| Compliance | Description | Data | Compliance | Description | Data |
|---|---|---|---|---|---|
| No | Ramp Run Slope (%) | 12.4 | N/A | Flare Slope LT (%) | N/A |
| No | Gutter Lip Height (in) | 0.25 | | Road Run Slope (%) | 0.2 |

**Remove & Replace Curb Ramp With Two New Directional Ramps or Equivalent. Grind Gutter Lip.**

**R204.3, R304.2.2, R302.7.2, STD 1115**
