# Access Compliance Report Public Rights-of-Way (Curb Ramps)

Main Street: ANTIGUA\_ST Cross Street: GUINIDA\_LN Location: SW

ADA ID: RPRK210923151354 Ramp Type: Type 1 - Perpendicular Diagonal Initial Pass/Fail: Fail Overall Compliance: No Severity Score: 32

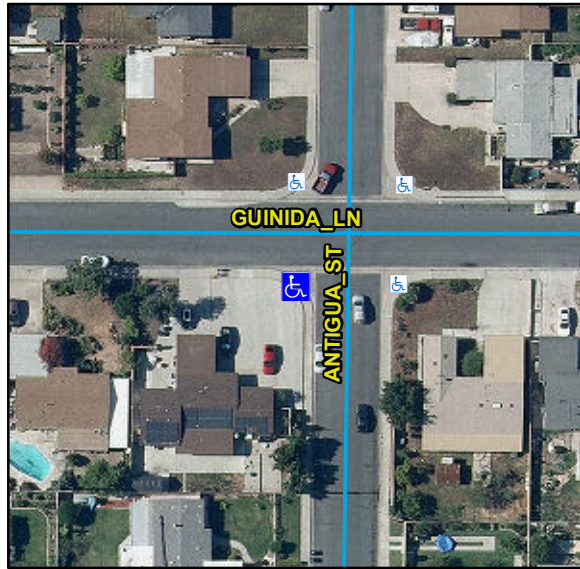
| Compliance | Description | Data | Compliance | Description | Data |
|---|---|---|---|---|---|
| No | Ramp Run Slope (%) | 13.7 | N/A | Flare Slope LT (%) | N/A |
| No | Gutter Lip Height (in) | 0.5 | | Road Run Slope (%) | 0.2 |

**Remove & Replace Curb Ramp With Two New Directional Ramps or Equivalent. Grind Gutter Lip.**

**R204.3, R304.2.2, R302.7.2, STD 1115**
