ADA ID: RPRK210923181406

Access Compliance Report Public Rights-of-Way (Curb Ramps)

Main Street: MILNEBURG_ST **Cross Street: BIENVILLE AVE** Location: NE

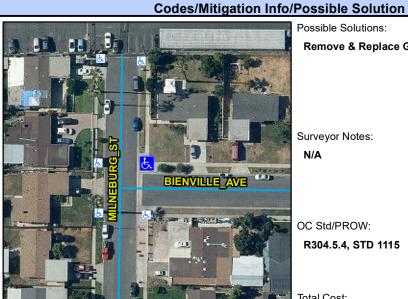
Overall Compliance: No Severity Score:

R304.5.4, STD 1115

Possible Solutions: Remove & Replace Gutter.
