# Access Compliance Report Public Rights-of-Way (Curb Ramps)

Main Street: GUINIDA\_LN Cross Street: GILBERT\_ST Location: SE

ADA ID: RPRK210924121233 Ramp Type: Type 1 - Perpendicular Diagonal Initial Pass/Fail: Fail Overall Compliance: No Severity Score: 0

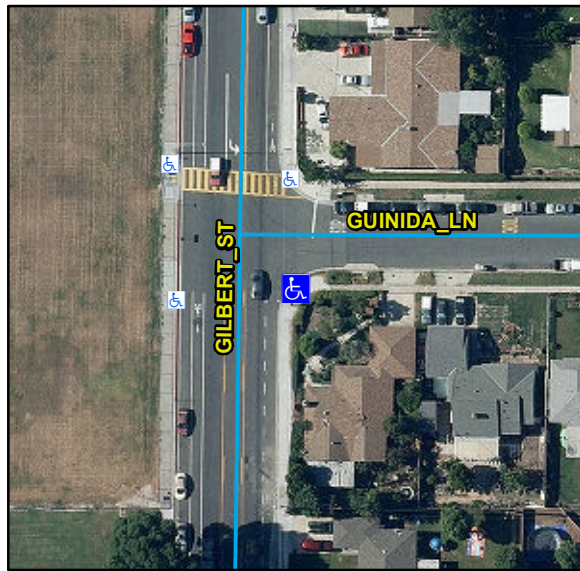
R304.2.2, STD 1115

Remove & Replace Curb Ramp With Two New Directional Ramps or Equivalent.
