# Access Compliance Report Public Rights-of-Way (Curb Ramps)

Main Street: PERDIDO\_ST Cross Street: BIENVILLE\_AVE Location: NE

ADA ID: RPRK210924131615 Ramp Type: Type 1 - Perpendicular Diagonal Initial Pass/Fail: Fail Overall Compliance: No Severity Score: 45

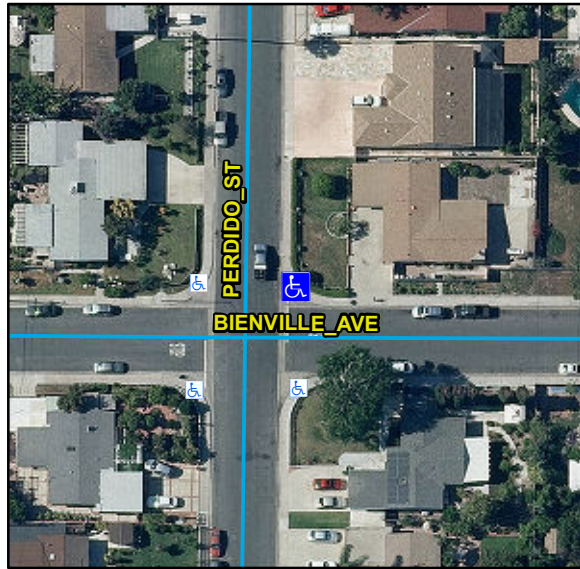
| Compliance | Description | Data | Compliance | Description | Data |
|---|---|---|---|---|---|
| No | Ramp Run Slope (%) | 15.5 | N/A | Flare Slope LT (%) | N/A |
| No | Ramp Cross Slope (%) | 5.4 | N/A | Flare Traversable LT | N/A |
| No | Gutter Lip Height (in) | 0.5 | | Road Run Slope (%) | 0 |

Remove & Replace Curb Ramp With Two New Directional Ramps or Equivalent.
