# Access Compliance Report Public Rights-of-Way (Curb Ramps)

Main Street: CHAPMAN\_AVE Cross Street: CHAPMAN\_AVE Location: S

ADA ID: RPRK210928154206 Ramp Type: Type 1 - Perpendicular Initial Pass/Fail: Fail Overall Compliance: No Severity Score: 30

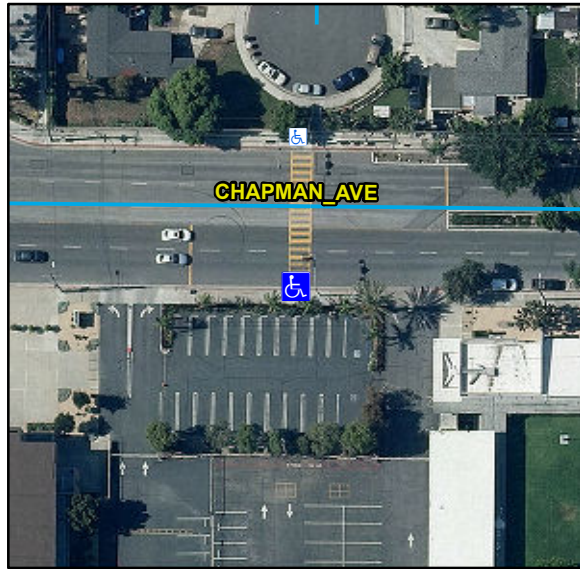
R304.2.2, R204.3, R302.7.2, STD 1115

| Compliance | Description | Data | Compliance | Description | Data |
|---|---|---|---|---|---|
| No | Ramp Run Slope (%) | 15 | N/A | Flare Slope LT (%) | N/A |
| No | Gutter Lip Height (in) | 0.5 | | Road Run Slope (%) | N/A |

Remove & Replace Entire Ramp.
