# Access Compliance Report

## Public Rights-of-Way

### (Curb Ramps)

Main Street: DALE\_ST Cross Street: CHAPMAN\_AVE Location: NW

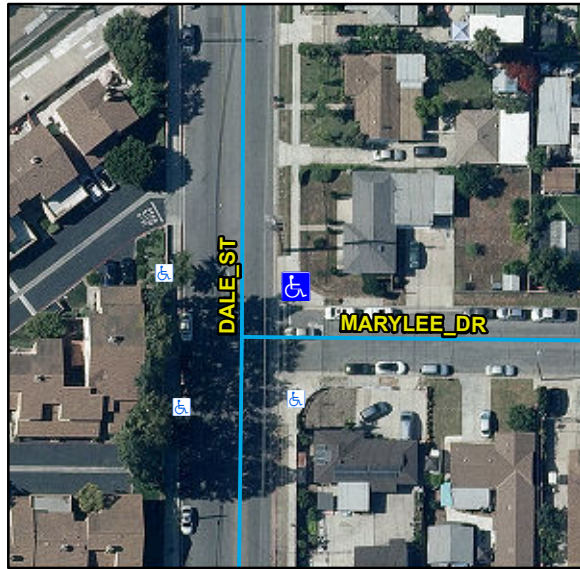
ADA ID: RPRK210928180405 Ramp Type: Type 1 - Perpendicular Diagonal Initial Pass/Fail: Fail Overall Compliance: No Severity Score: 2

| Compliance | Description | Data | Compliance | Description | Data |
|---|---|---|---|---|---|
| No | Ramp Cross Slope (%) | 2.2 | N/A | Flare Traversable LT | N/A |

**Remove & Replace Curb Ramp With Two New Directional Ramps or Equivalent.**

**R204.3, R304.5.3, STD 1115**
