Access Compliance Report Public Rights-of-Way (Curb Ramps)

Main Street: MCFADDEN_AVE **Cross Street:** WILSON_ST **Location:** NW

ADA ID: RPRK210930113620 **Ramp Type:** Type 1 - Perpendicular Diagonal Initial Pass/Fail: Fail **Overall Compliance:** No **Severity Score:** 15

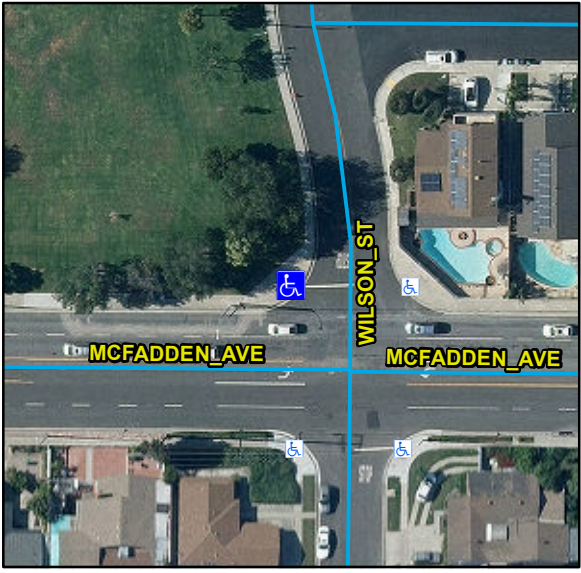
Compliance	Description	Data	Compliance	Description	Data
N/A	Ramp Length (in)	80	N/A	Flare Type LT	
Yes	Ramp Width (in)	48			N/A
No	Ramp Run Slope (%)	11.3	N/A	Flare Slope LT (%)	N/A
Yes	Ramp Cross Slope (%)	1.3	N/A	Flare Traversable LT	N/A
N/A	Landing Present	N/A	N/A	Flare Type RT	
N/A	Landing Length (in)	N/A			N/A
N/A	Landing Width (in)	N/A	N/A	Flare Slope RT (%)	N/A
N/A	Landing Run Slope (%)	N/A	N/A	Flare Traversable RT	N/A
N/A	Landing Cross Slope (%)	N/A	N/A	DWS Provided	N/A
N/A	Landing Movement Obstructed?	N/A	N/A	DWS Contrast	N/A
	Landing Movement Type	N/A	N/A	DWS Length (in)	N/A
N/A	Landing Shared	N/A	N/A	DWS Full Width	N/A
N/A	Clear Space	Yes	N/A	DWS Offset Left (in)	N/A
N/A	Clear Space To Crosswalk (in)	N/A	N/A	DWS Offset Right (in)	N/A
N/A	Marked Crosswalk 1	No	N/A	Marked Crosswalk 2	No
	Crossing 1 Direction	S		Crossing 2 Direction	E
	Marked Crosswalk 1 Width (in)	N/A		Marked Crosswalk 2 Width (in)	N/A

N/A	Ramp Inside Crosswalk 1	N/A	Yes	Ramp Inside Crosswalk 2	N/A
	Crossing 1 Slope (%)	7.9		Crossing 2 Slope (%)	1.4
	Crossing 1 Cross Slope (%)	0		Crossing 2 Cross Slope (%)	2.6
N/A	Gutter Ponding	N/A	N/A	Curb Slope	4.5
Yes	Gutter Lip Height (in)	0		Road Run Slope (%)	1.7
N/A	Gutter Run Slope (%)	N/A		Road Cross Slope (%)	0
N/A	Gutter Cross Slope (%)	N/A			
Yes	Overall Surface Condition: Acceptable		No	Perp Joint Present	No
	Cross Gutter Present?	No		Spandrel Present?	No
	Replace Cross Gutter?	N/A		Replace Spandrel?	N/A

Possible Solutions:
Remove & Replace Curb Ramp With Two New Directional Ramps or Equivalent.
