# Access Compliance Report Public Rights-of-Way (Curb Ramps)

Main Street: VAN\_BUREN\_ST Cross Street: WORTHY\_DR Location: NE

ADA ID: RPRK210930124524 Ramp Type: Type 1 - Perpendicular Diagonal Initial Pass/Fail: Fail Overall Compliance: No Severity Score: 30

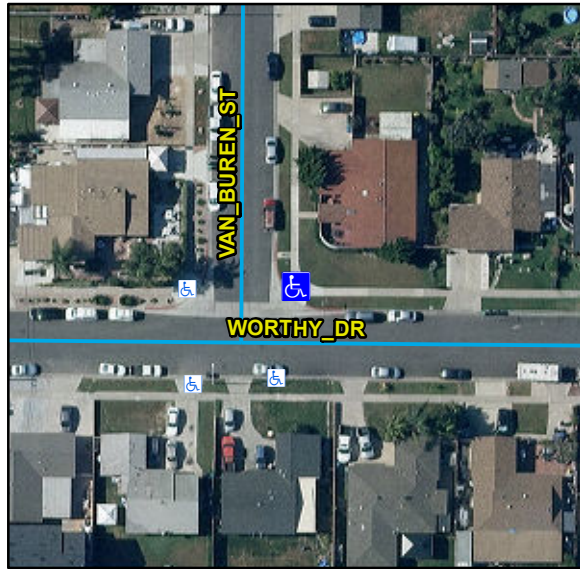
| Compliance | Description | Data | Compliance | Description | Data |
|---|---|---|---|---|---|
| No | Ramp Run Slope (%) | 12.2 | N/A | Flare Slope LT (%) | N/A |

Remove & Replace Curb Ramp With Two New Directional Ramps or Equivalent.
