# Access Compliance Report Public Rights-of-Way (Curb Ramps)

Main Street: WORTHY\_DR Cross Street: VAN\_BUREN\_ST Location: NW

ADA ID: RPRK210930124709 Ramp Type: Type 1 - Perpendicular Diagonal Initial Pass/Fail: Fail Overall Compliance: No Severity Score: 15

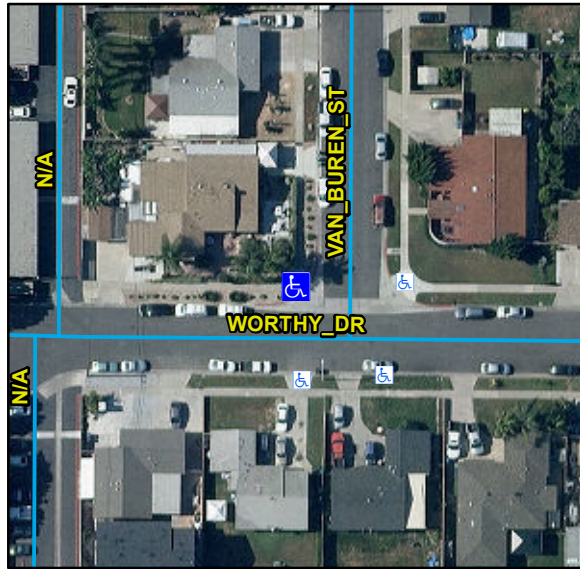
| Compliance | Description | Data | Compliance | Description | Data |
|---|---|---|---|---|---|
| No | Ramp Run Slope (%) | 11.4 | N/A | Flare Slope LT (%) | N/A |

Remove & Replace Curb Ramp With Two New Directional Ramps or Equivalent.
