# Access Compliance Report Public Rights-of-Way (Curb Ramps)

Main Street: MCFADDEN\_AVE Cross Street: VAN\_BUREN\_ST Location: NW

ADA ID: RPRK210930130643 Ramp Type: Type 1 - Perpendicular Diagonal Initial Pass/Fail: Fail Overall Compliance: No Severity Score: 2

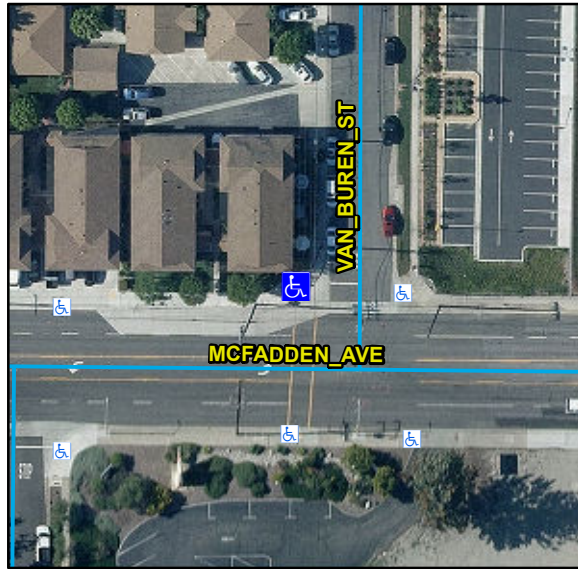
| Compliance | Description | Data | Compliance | Description | Data |
|---|---|---|---|---|---|
| No | Ramp Cross Slope (%) | 2.4 | N/A | Flare Traversable LT | N/A |

Remove & Replace Curb Ramp With Two New Directional Ramps or Equivalent.
