Access Compliance Report Public Rights-of-Way (Curb Ramps)

Main Street: MADISON AVE Cross Street: VAN_BUREN_ST NW Location: Ramp Type:Type 1 - Perpendicular Diagonal Initial Pass/Fail: Fail ADA ID: RPRK211001193219 **Overall Compliance: No Severity Score:** 20

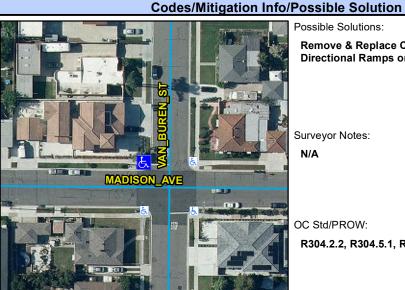
R304.2.2, R304.5.1, R304.5.3, STD 1115

Remove & Replace Curb Ramp With Two New Directional Ramps or Equivalent.
