# Access Compliance Report Public Rights-of-Way (Curb Ramps)

Main Street: VAN\_BUREN\_ST Cross Street: MADISON\_AVE Location: NE

ADA ID: RPRK211001193742 Ramp Type: Type 1 - Perpendicular Diagonal Initial Pass/Fail: Fail Overall Compliance: No Severity Score: 34

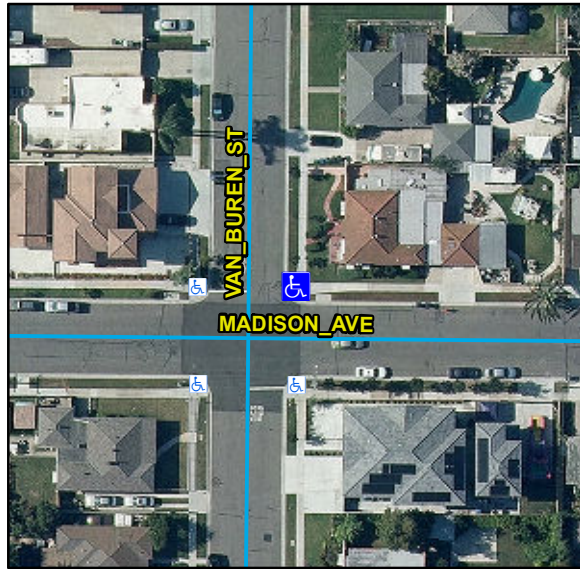
| Compliance | Description | Data | Compliance | Description | Data |
|---|---|---|---|---|---|
| No | Ramp Width (in) | 36 | | | N/A |
| No | Ramp Run Slope (%) | 12.3 | N/A | Flare Slope LT (%) | N/A |

Remove & Replace Curb Ramp With Two New Directional Ramps or Equivalent.

R304.2.2, R304.5.1, STD 1115
