# Access Compliance Report Public Rights-of-Way (Curb Ramps)

Main Street: BOLSA\_AVE Cross Street: ADAMS\_ST Location: NW

ADA ID: RPRK211004174023 Ramp Type: Type 1 - Perpendicular Diagonal Initial Pass/Fail: Fail Overall Compliance: No Severity Score: 20

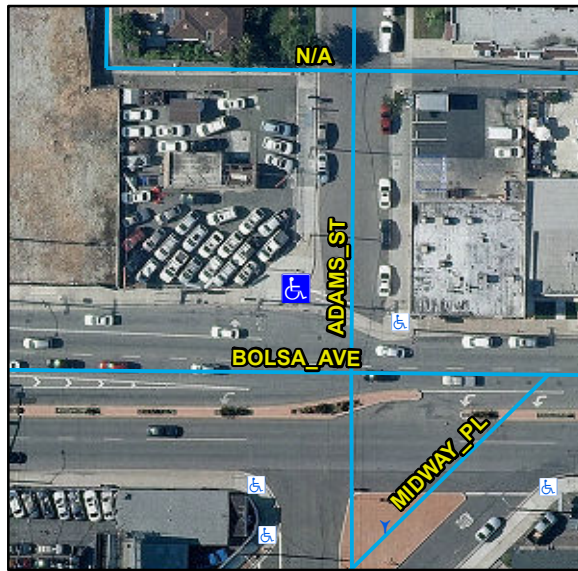
R304.2.2, R304.5.1, STD 1115

Remove & Replace Curb Ramp With Two New Directional Ramps or Equivalent.
