# Access Compliance Report Public Rights-of-Way (Curb Ramps)

Main Street: PURDY\_ST Cross Street: BOLSA\_AVE Location: SW

ADA ID: RPRK211005133509 Ramp Type: Type 1 - Perpendicular Diagonal Initial Pass/Fail: Fail Overall Compliance: No Severity Score: 16

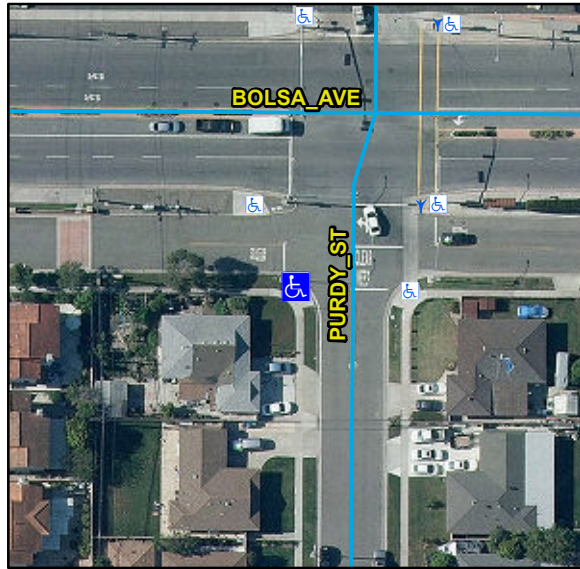
| Compliance | Description | Data | Compliance | Description | Data |
|---|---|---|---|---|---|
| No | Ramp Run Slope (%) | 11.7 | N/A | Flare Slope LT (%) | N/A |
| No | Ramp Cross Slope (%) | 2.1 | N/A | Flare Traversable LT | N/A |

Remove & Replace Curb Ramp With Two New Directional Ramps or Equivalent.

R304.2.2, R304.5.3, STD 1115
