# Access Compliance Report Public Rights-of-Way (Curb Ramps)

Main Street: HUNTER\_LN Cross Street: BOLSA\_AVE Location: SW

ADA ID: RPRK211005134106 Ramp Type: Type 1 - Perpendicular Diagonal Initial Pass/Fail: Fail Overall Compliance: No Severity Score: 15

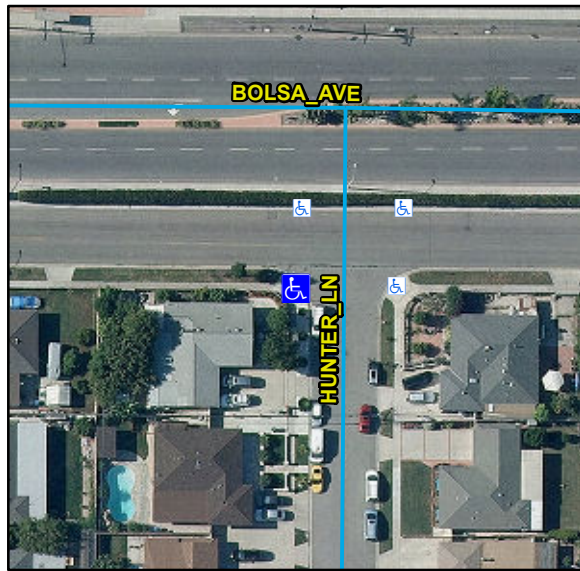
| Compliance | Description | Data | Compliance | Description | Data |
|---|---|---|---|---|---|
| No | Ramp Run Slope (%) | 11.1 | N/A | Flare Slope LT (%) | N/A |

**Remove & Replace Curb Ramp With Two New Directional Ramps or Equivalent.**
