Access Compliance Report Public Rights-of-Way (Curb Ramps)

Main Street: HARHAY_AVE **Cross Street:** PACIFIC_ST **Location:** SE

ADA ID: RPRK211005173127 **Ramp Type:** Type 1 - Perpendicular Diagonal Initial Pass/Fail: Fail **Overall Compliance:** No **Severity Score:** 30

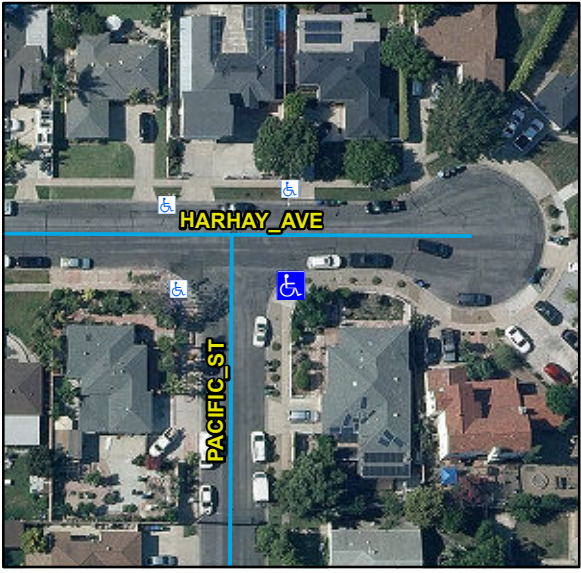
Compliance	Description	Data	Compliance	Description	Data
N/A	Ramp Length (in)	83	N/A	Flare Type LT	
Yes	Ramp Width (in)	48			N/A
No	Ramp Run Slope (%)	14.5	N/A	Flare Slope LT (%)	N/A
Yes	Ramp Cross Slope (%)	1	N/A	Flare Traversable LT	N/A
N/A	Landing Present	N/A	N/A	Flare Type RT	
N/A	Landing Length (in)	N/A			N/A
N/A	Landing Width (in)	N/A	N/A	Flare Slope RT (%)	N/A
N/A	Landing Run Slope (%)	N/A	N/A	Flare Traversable RT	N/A
N/A	Landing Cross Slope (%)	N/A	N/A	DWS Provided	N/A
N/A	Landing Movement Obstructed?	N/A	N/A	DWS Contrast	N/A
	Landing Movement Type	N/A	N/A	DWS Length (in)	N/A
N/A	Landing Shared	N/A	N/A	DWS Full Width	N/A
N/A	Clear Space	Yes	N/A	DWS Offset Left (in)	N/A
N/A	Clear Space To Crosswalk (in)	N/A	N/A	DWS Offset Right (in)	N/A
N/A	Marked Crosswalk 1	No	N/A	Marked Crosswalk 2	No
	Crossing 1 Direction	N		Crossing 2 Direction	W
	Marked Crosswalk 1 Width (in)	N/A		Marked Crosswalk 2 Width (in)	N/A

N/A	Ramp Inside Crosswalk 1	N/A	Yes	Ramp Inside Crosswalk 2	N/A
	Crossing 1 Slope (%)	8		Crossing 2 Slope (%)	2.3
	Crossing 1 Cross Slope (%)	1		Crossing 2 Cross Slope (%)	3.5
N/A	Gutter Ponding	N/A	No	Curb Slope	7.6
Yes	Gutter Lip Height (in)	0		Road Run Slope (%)	1.8
N/A	Gutter Run Slope (%)	N/A		Road Cross Slope (%)	3.8
N/A	Gutter Cross Slope (%)	N/A			
Yes	Overall Surface Condition: Acceptable		Yes	Perp Joint Present	Yes
	Cross Gutter Present?	No		Spandrel Present?	No
	Replace Cross Gutter?	N/A		Replace Spandrel?	N/A

Possible Solutions:
Remove & Replace Curb Ramp With Two New Directional Ramps or Equivalent.
