# Access Compliance Report Public Rights-of-Way (Curb Ramps)

Main Street: CEDARWOOD\_AVE Cross Street: HARHAY\_AVE Location: NE

ADA ID: RPRK211005174202 Ramp Type: Type 1 - Perpendicular Diagonal Initial Pass/Fail: Fail Overall Compliance: No Severity Score: 32

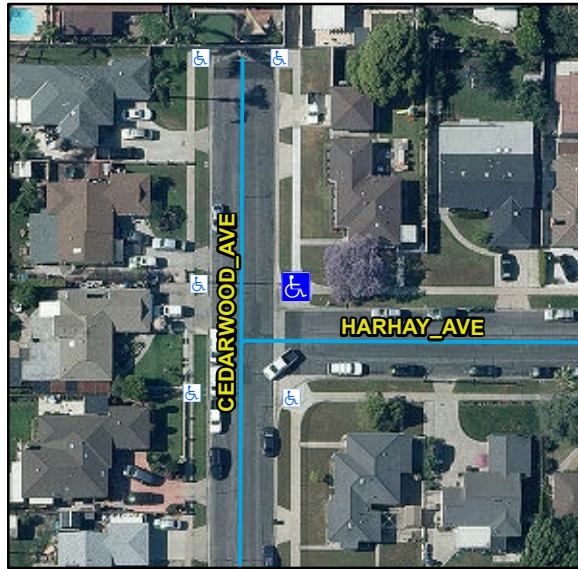
| Compliance | Description | Data | Compliance | Description | Data |
|---|---|---|---|---|---|
| No | Ramp Run Slope (%) | 12.1 | N/A | Flare Slope LT (%) | N/A |
| No | Ramp Cross Slope (%) | 3.2 | N/A | Flare Traversable LT | N/A |

Remove & Replace Curb Ramp With Two New Directional Ramps or Equivalent.
